TECHLINE
BY DONNY PETERSEN

Isolated Drive System

Is H-D's new IDS kit a fix or an enhancement?

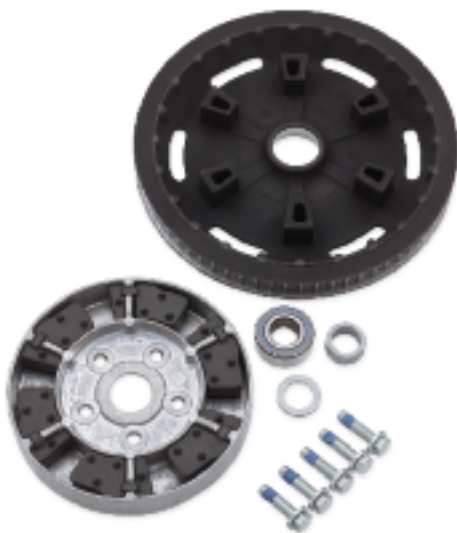
Isolated Drive System (IDS) kit rear pulley has six stops cast on the inside portion that faces the rear wheel compensator bowl. The rear drive belt sprocket-pulley compensator bowl has six rubber dampers incorporated in it to form an isolated secondary drive system that buttresses the pulley stops.

The IDS cure is to rubber-mount the rear pulley sprocket to absorb traveling pulses and prevent their transference back, or at least disrupt the wave pattern of the pulses. Harley-Davidson, in order to preserve traditional design, goes to inordinate lengths to mask symptoms as opposed to curing some problems. We now have compensator sprockets at the front and rear of the powertrain to curb the fifth-gear clatter. Therefore, the spur-cut gears are not the origin of fifth-gear clatter, but the end result of harmonic pulses traveling unhindered back and forth along the powertrain, much like exhaust pulses do in the exhaust system. Time will tell how reliable the rear rubber-mounted pulley is.

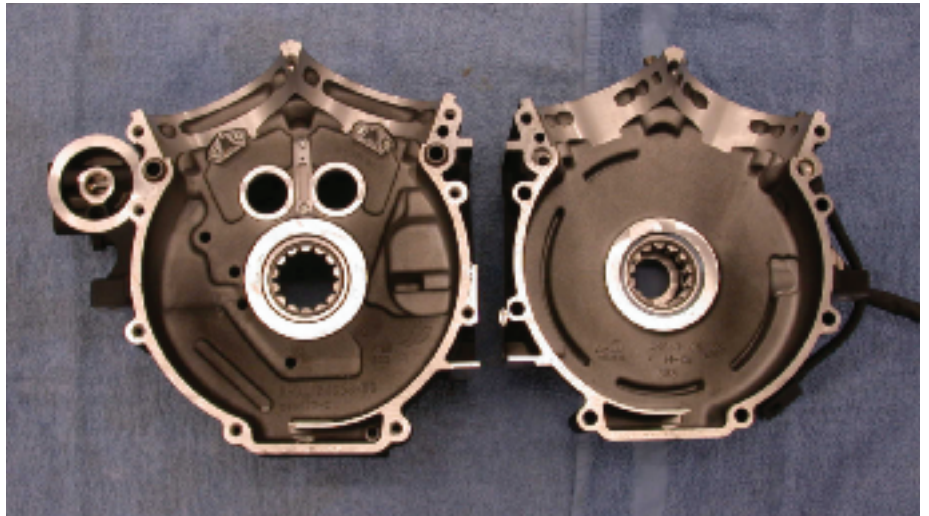
I feel that the sprocket (left) shaft bearing, which now uses the same roller bearing as the pinion (right) side, also has a part in transmitting power pulses along the drivetrain.

A roller bearing design, no matter how big and strong, is unable to withstand these side forces for a long time. I don't like this roller bearing, plain and simple. It replaced the very able, opposed, tapered Timken bearings and mating races, which were used with great and enduring success from 1956 to 2002. As much as I dislike the use of this roller bearing for this particular purpose, I cannot single it out and blame it for the fifth-gear clatter. This bearing began use in 2003 in all rubber-mount Twin Cams and in 2000 in all Softail models, but the gear clatter did not occur until 2007. To further complicate the issue, the 2006 Dyna is outfitted with the six-speed Cruise Drive and the sprocket shaft roller bearing, but there are not any complaints that I am aware of regarding clatter. The noise begins in the engine, possibly as a spark knock and travels through the powertrain back to the rear pulley.

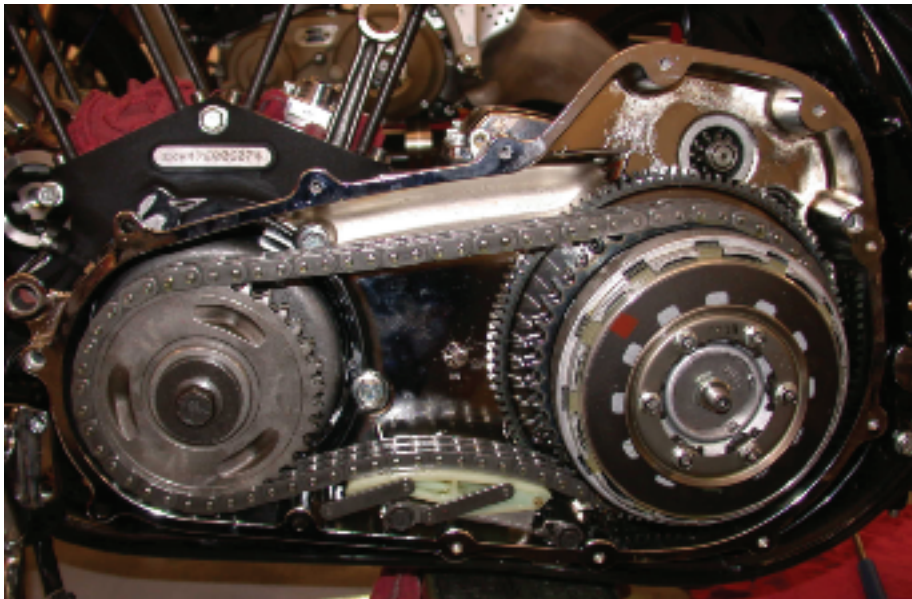
I think the real culprit is the compensating gear in the primary. It's not strong enough to do the job in fifth, so it's unloading.

However, the kicker that brings this noise problem all together is the super-sized primary gear ratios compared to the conservative ratios in predecessor Twin Cams. We move from a compensator engine sprocket of the antecedent 25 tooth up to a radical 34 tooth. This overwhelms the compensating sprocket's capacity to absorb power pulses as effectively as before. Higher gearing always encourages the possibility of spark knock, especially when overcoming the effects of the massive sprocket going up the rpm range. The pulses roll down the powertrain only to return back via the rigid-mounted, energy-transferring, rear pulley sprocket, particularly at lower rpm levels. The returning harmonic pulses find the absorption point of least resist-

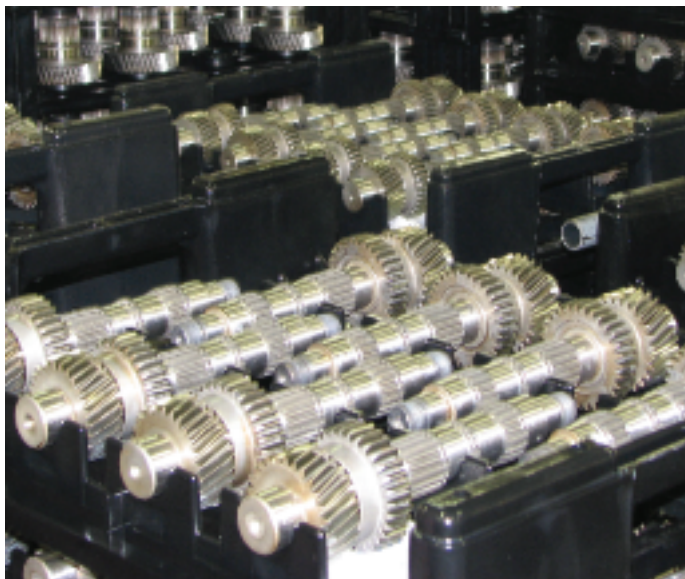
I believe kinetic energy pulses, or refraction, roll backward from the rear wheel pulley and through the powertrain. They reenter the transmission from the back, causing the backlash clatter in fifth gear. The mainshaft and countershaft fifth gears absorb the power pulses creating the noise via backlash clatter. Backlash occurs within the mating spur or straight-cut gears because the gear teeth are not in constant contact. There are spaces between the gear teeth. Sixth, fourth, third, and second gears are helical-cut, so the gear teeth are in constant contact with each other. Thus, backlash is not an issue in helical-cut gears. If there were no spur-cut gears in the Cruise Drive, this fifth-gear clatter would not exist. Of course, the refracted energy pulses might manifest themselves in other ways. Or they might not manifest at all, just roll back and forth like exhaust pulses. The spur-cut, first-gear set does not make any discernible refractive backlash noise because the fifth gears have already absorbed the returning pulses.

The 2007 H-D six-speed tranny uses both spur-(straight-cut) and helical-cut gears, as you can see on these tranny components at a H-D manufacturing facility.
