TECHLINE
BY DONNY PETERSEN

Isolated Drive System

Is H-D's new IDS kit a fix or an enhancement?

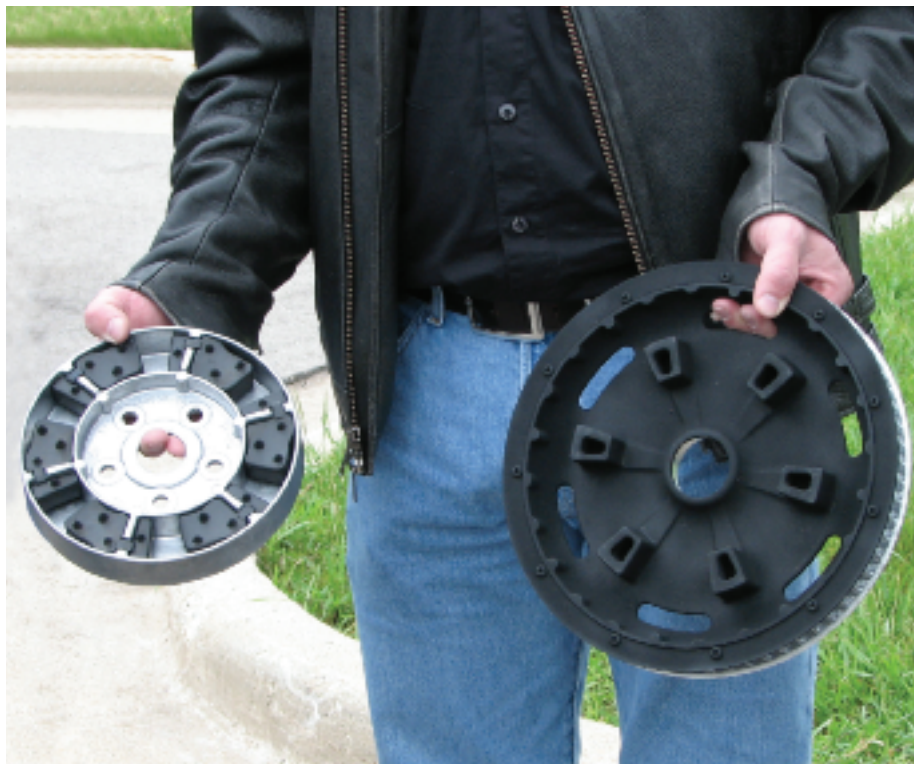
All 2008 Touring models come equipped with an Isolated Drive System (IDS). This IDS sprocket kit (#40287-07) is now available for retrofitting on all 2007 Touring models with a rubber-mounted rear wheel sprocket-pulley, except for the H-D International (HDI) Touring models sold in Japan.

The IDS kit will work on bikes with original equipment (OE) wheels and all H-D accessory wheels, except the 80-spoke laced wheel (#42925-04), the polished-aluminum solid spun disc wheel (#43760-03), or the slotted six-spoke wheel (#43932-02, chrome/#43933-02, black). The rear pulley has six stops cast
