### TECHNICAL GUIDELINES FOR CLARITY CAM COVER:

2001-2012 Twin Cam Models **except 2001-2012 FL Touring models.**

0177-2003

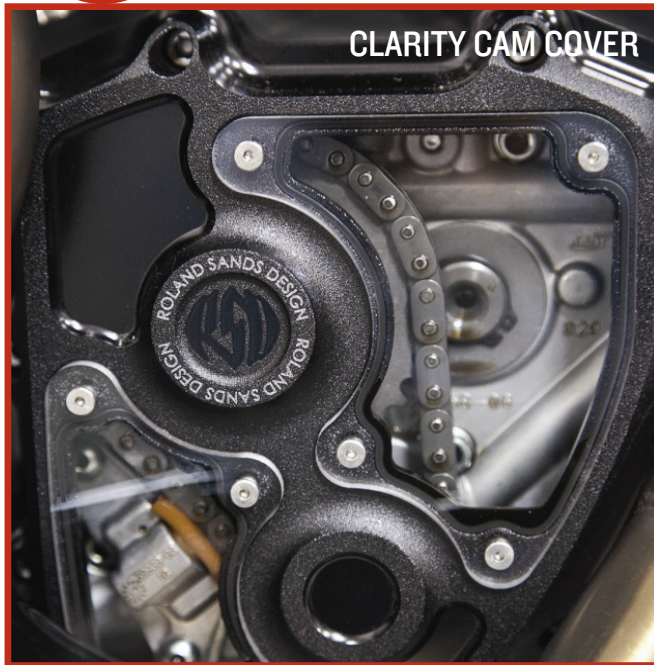
The RSD Clarity Cam Cover 0177-2003 contains two pre-installed Lexan polycarbonate windows. These windows are very resistant to almost everything a motorcycle will be exposed to, however, extra care and preparation must be taken when installing the cam cover near the exhaust system. The Lexan polycarbonate windows must be at least 5/16" away from the exhaust pipe to insure the temperature does not exceed the capabilities of the Lexan. Additional clearance is recommended to preserve the optical clarity of the Lexan window as well as reducing the amount of heat introduced to the engine from the exhaust. Take measurements when installing the exhaust system and make sure that the exhaust **NEVER** contacts the Lexan windows, bolts, or the aluminum cam cover. Lexan is very durable but it must be treated just like any plastic and cannot come into contact with the exhaust pipes. The Lexan windows just like any plastic will melt if in direct contact with the exhaust pipe. If the Lexan windows have less than adequate clearance premature discoloration, cracking, or melting may occur causing severe failure and/or possible injury to the rider. RSD recommends the use of "high pipes" or exhaust that runs above the cam cover which eliminates any potential exhaust contact.

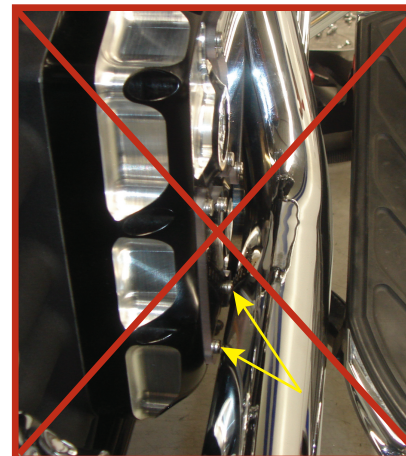
### 2000-08 FL MODELS: INADEQUATE CLEARANCE

-CONTACT WITH BOLT HEADS WILL CAUSE SEVERE LEXAN FAILURE!

1. THERE MUST BE AT LEAST 5/16" AIR GAP BETWEEN THE EXHAUST AND THE LEXAN WINDOWS, BOLTS, AND COVER.
2. ABSOLUTELY NO CONTACT BETWEEN THE LEXAN WINDOWS, BOLTS, OR ALUMINUM CAM COVER.
3. DO NOT USE BRAKE CLEANER, ACETONE, OR ANY HARSH CHEMICALS DURING INSTALLATION.
4. USE PLEXXUS CLEANER FOR CLEANING. IF ANY OTHER CLEANERS ARE USED READ THE LABEL TO VERIFY COMPATIBILITY WITH LEXAN.
